Automated State-Survey System for Monitoring Salt Damages on Plastered Wall Surfaces

Abstract

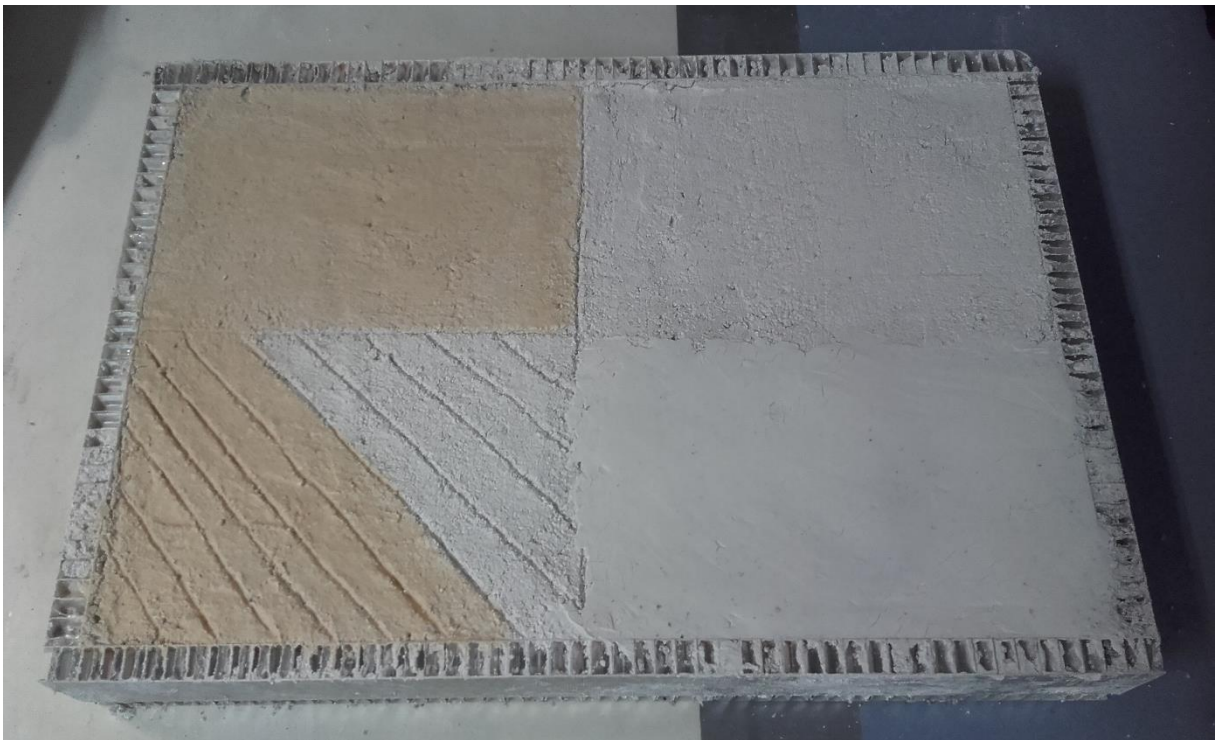
Fig. 1. The test substrate

As the subject of the investigations, a plastered test substrate was made in an aluminum frame. The material of the substrate was prepared from lime putty and quartz sand with a binder to aggregate ratio of 1:4. The plaster was applied in two layers. The surface finish of the substrate was prepared differently in the four quarters of the plaster (Fig 1.) to create altering optical environment for the expected efflorescence:

- upper-right corner in Fig 1. (upper-left corner in final position) - rendered surface
- lower-right corner in Fig 1. (upper-right corner in final position) - smoothed surface
- upper-left corner in Fig 1. (lower-left corner in final position) - rendered surface painted with yellow ochre
- lower-left corner in Fig 1. (lower-right corner in final position) - rendered, diagonally patterned surface partially painted with yellow ochre

Finally, we erected the frame, turned 90° counter-clockwise, and placed it in front of the state-survey unit.

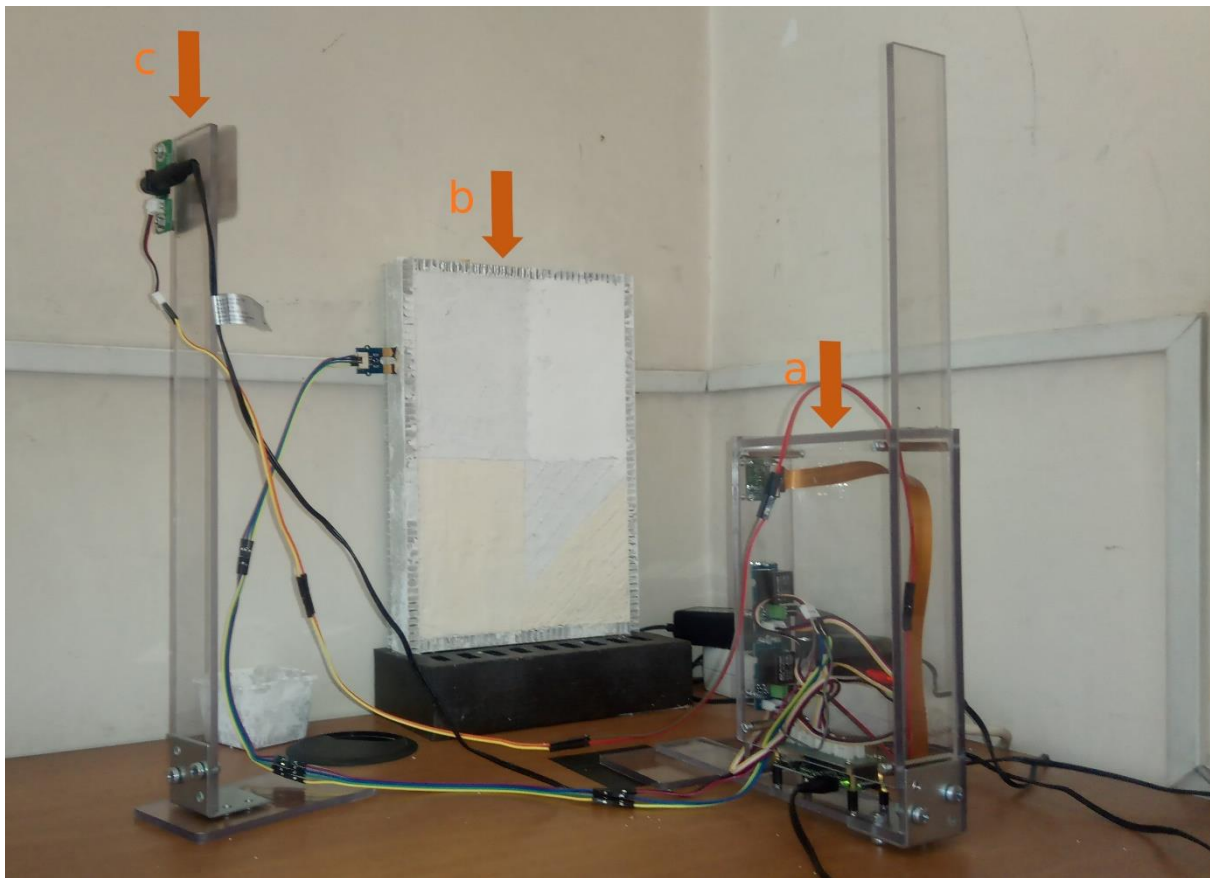
Fig. 2. The hardware - (a) state survey unit (b) test substrate (c) LED lamp

The core of the hardware was a Raspberry Pi Zero W single-board computer, which was equipped with a Raspberry Pi V 2.1 camera module and a Grove Base Hat for the connection of the peripherals, like the sensors and the relays. The relative air humidity and the temperature are measured with an SHT31 Grove I²C temperature and humidity sensor, and an analog moisture sensor (Grove Moisture Sensor v1.4) which was placed 20mm deep in the sample substrate. To ensure stable light conditions for the photos to be taken, an LED lamp was attached, that was supplied by electric power individually. Two relays were also used to switch a LED light and to switch off the power of the moisture sensor to reduce its corrosion during the time of the project. Finally, Raspbian Linux operation system was installed on the computer. The price of the survey unit was round € 130, which is an acceptable price; however, we aimed to reduce the costs by testing possible alternative hardware.

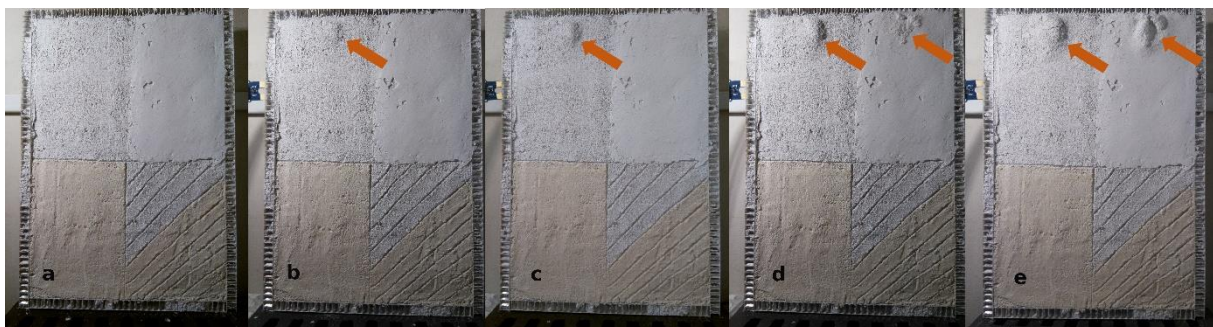
Fig. 3. Changing state of the plaster on some selected side-light pictures taken by the survey unit (a) June 2019; (b) September 2019; (c) December 2019; (d) March 2020; (e) May 2020

It was realized in the beginning already, that the effect of the diluted saline solutions would not turn out for a long time, neither in the case of sodium-chloride nor of calcium-nitrate. The reason is that the salt, which was stemming from the injections, did not make such amount of salt accumulation, which would cause efflorescence on the surface. Therefore, as far as we aimed a visible result, we decided to add a series of saturated saline solution injections, which were followed by efflorescence within a few days. This phenomenon can be observed in the photo series of Fig 3. With the help of the daily taken photos, we can follow the changes in the salt deposit on the surface of the sample substrate.

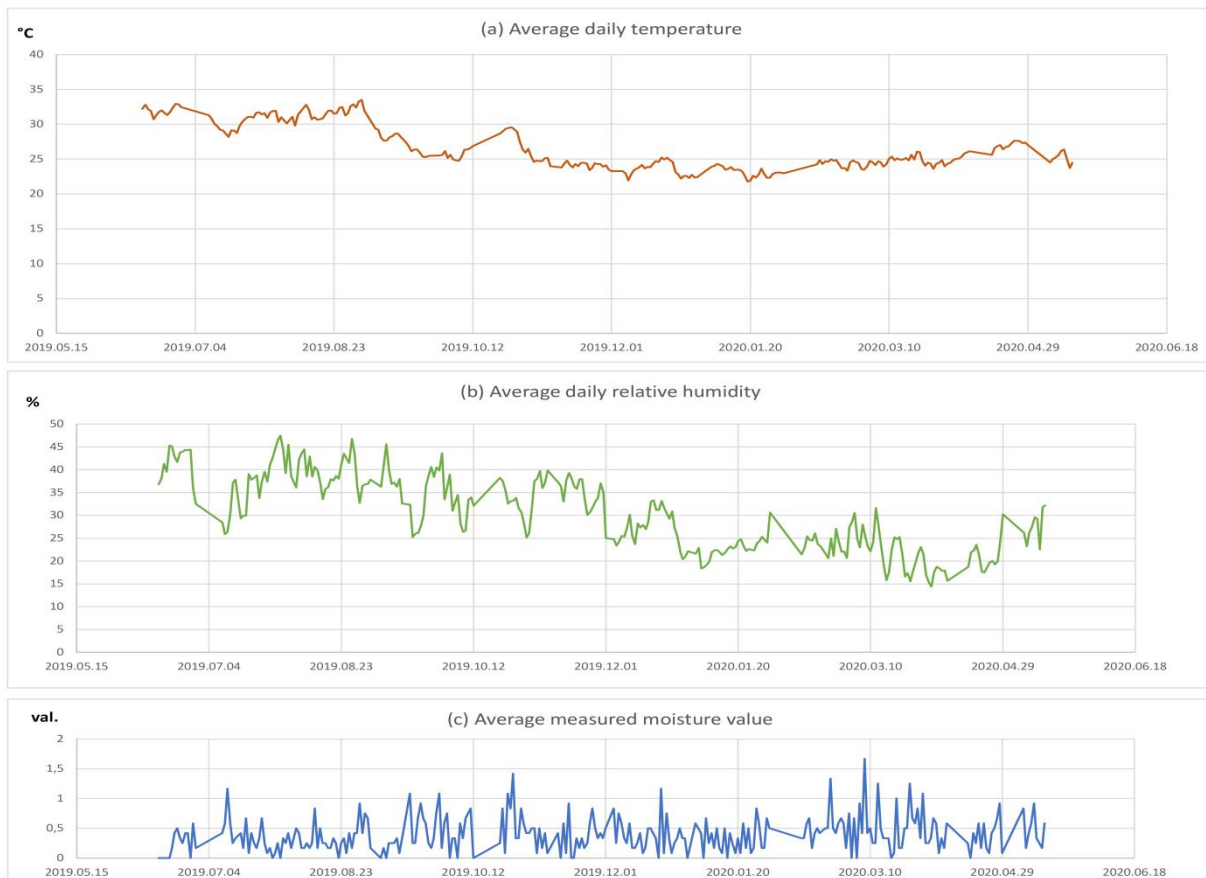
Fig. 4. Changes in the environmental circumstances (temperature, relative humidity) and the moisture

The SHT31 Grove I2C temperature and humidity sensor seemed to work well. The daily environmental circumstances were recorded properly without failure. The average values of the daily recorded data are demonstrated by the diagrams in Fig 4.a and Fig 4.b.

The applied contact moisture sensor, however, seemed to be idle, because of the low sensitivity to the moisture in the solid structure (Fig 4.c). While far from the injection (controlled with a Voltcraft MF-90 capacitive moisture meter unit) the moisture content of the sample substrate was approximately 29-33%, close to the efflorescence (at the place where the built-in sensor was placed) the value was 42-48%, however, the sensor showed no relevant changes regarding the values.

Testing the sensor independently from the system, even round 100% percent of water/moisture content showed hardly any changes at its values, so this sensor type, which was developed to indicate soil moisture, was considered to be inadequate for our goals.
